Quality Assurance and Source Inspection

Contract #: 04-0120F4Cty: SF/ALA Rte: 80 PM: 13.2/13.9File #: 69.28**WELDING INSPECTION REPORT****Resident Engineer:** Pursell, Gary**Address:** 333 Burma Road**City:** Oakland, CA 94607**Report No:** WIR-001962**Date Inspected:** 15-Apr-2008**Project Name:** SAS Superstructure**OSM Arrival Time:** 1400**Prime Contractor:** American Bridge/Fluor Enterprises, a JV**OSM Departure Time:** 2300**Contractor:** Zhenhua Port Machinery Company, Ltd (ZPMC), Changxing Island **Location:** Shanghai, China**CWI Name:** Sun Wie**CWI Present:** Yes No**Inspected CWI report:** Yes No N/A**Rod Oven in Use:** Yes No N/A**Electrode to specification:** Yes No N/A**Weld Procedures Followed:** Yes No N/A**Qualified Welders:** Yes No N/A**Verified Joint Fit-up:** Yes No N/A**Approved Drawings:** Yes No N/A**Approved WPS:** Yes No N/A**Delayed / Cancelled:** Yes No N/A**Bridge No:** 34-0006**Component:** OBG Deck Panels**Summary of Items Observed:**

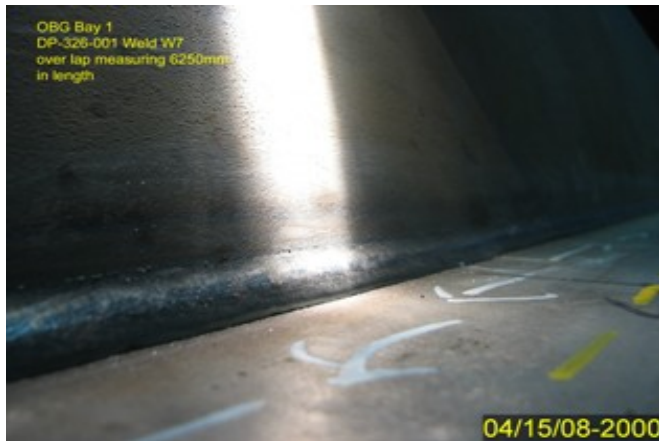
of the OBG Deck Panels. These functions include; closed rib press forming, hole drilling at ends of U-Ribs using a drill template, PJP bevel preparation, closed rib splice FCAW welding, closed rib diaphragm fit-up and FCAW welding, closed rib to deck plate fit-up and tack welding.
